## PRODUCT SAFETY RECALL

We wish to advise of a possible production defect tolerance issue regarding the below Whiteline rear sway bars.

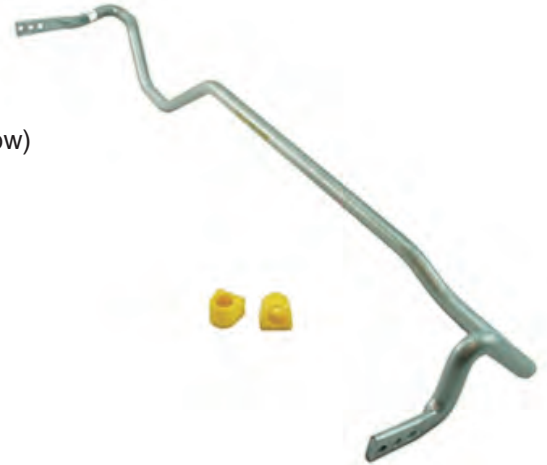
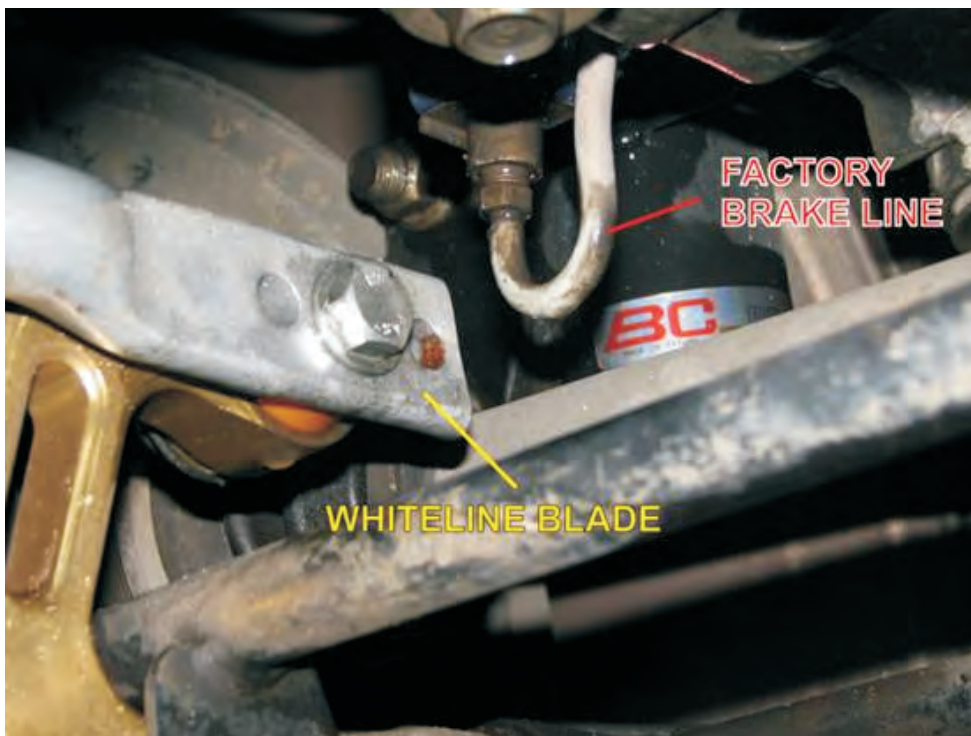
Possible blade clearance issues with factory brake line (refer image below)

Possible blade clearance issues with factory brake line  
(refer image below)
